# 05.10.2016

Permanent link:  
[https://iqwiki.iqo.uni-hannover.de/doku.php?id=groups:mg:project\\_ptb-cavity:labbook:2016-10:labbookentry-2016-10-05&rev=1475782000](https://iqwiki.iqo.uni-hannover.de/doku.php?id=groups:mg:project_ptb-cavity:labbook:2016-10:labbookentry-2016-10-05&rev=1475782000)

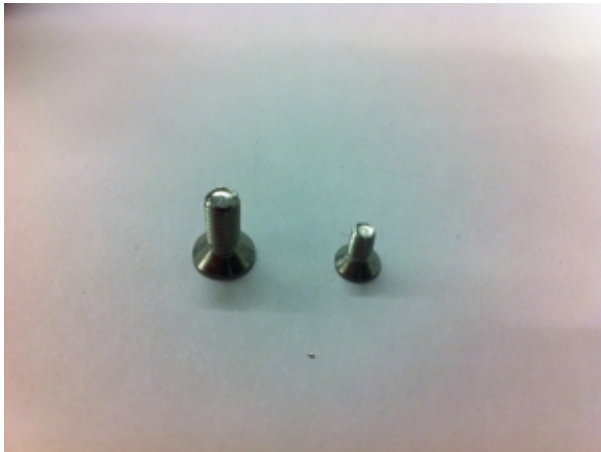
- Vacuum chamber was cleaned with dishwashing detergent
- Discussion about the breadboard (M3 screw size, small passage for the light, aluminium) and spacer (3cm, plastic) for incouple and outcouple light from the cavity
- Mounting (holes for countersunk head screws) was repaired
- Countersunk head screws installed in mounting. Probably, screws made of V2A steel:
