Permanent link:  
<https://iqwiki.iqo.uni-hannover.de/doku.php?id=groups:mg:reslab:labbook:2017-01:labbookentry-2017-01-02>

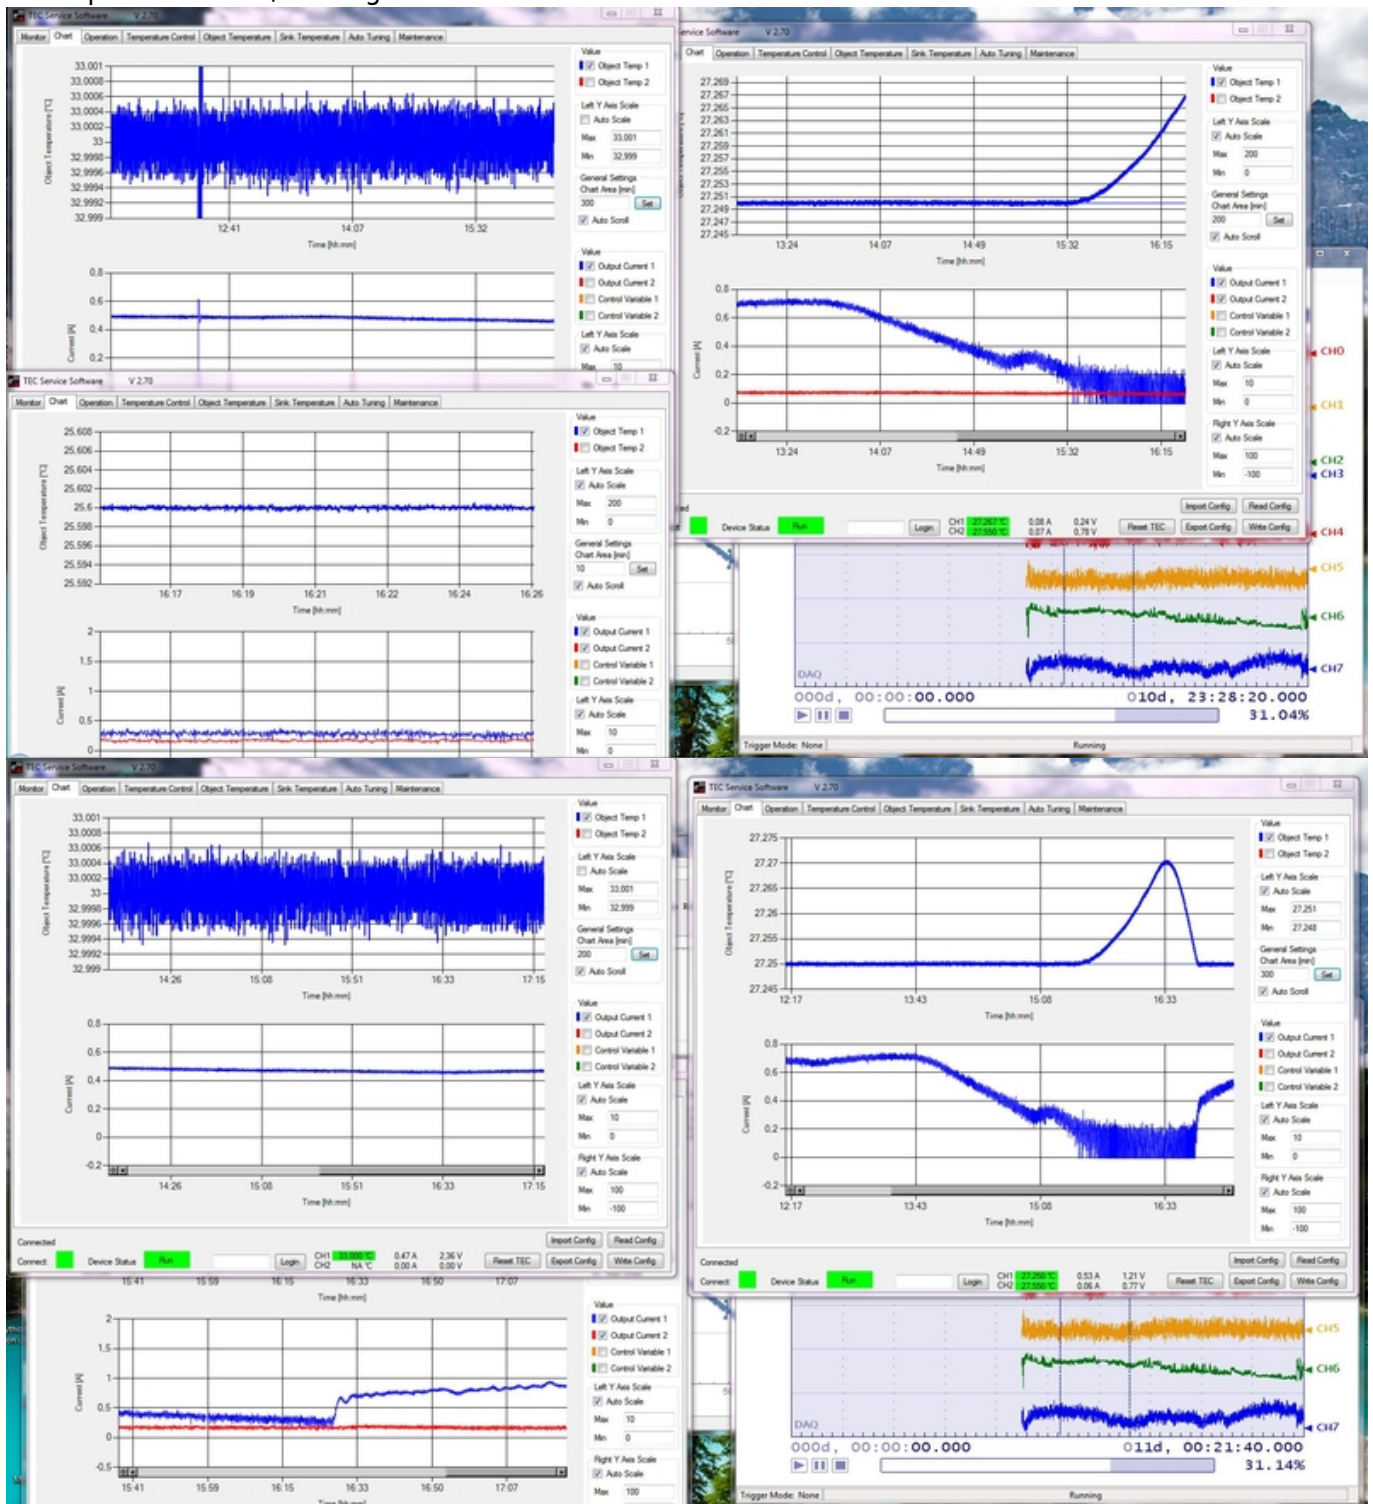
We install a door from the acoustic box and saw a heating process. At 16:27 we relieve the door. It can be seen that the temperature from R2 rises faster than R1. The reason for this is that R2 hasn't a complete acoustic/heating shield.
